# NHDOT SPR2 PROGRAM

## RESEARCH PROGRESS REPORT

<b>Project #</b> 26962M		<b>Report Period</b> Year: 2018 <input type="checkbox"/> Q1 (Jan-Mar) <input type="checkbox"/> Q2 (Apr-Jun) <input checked="" type="checkbox"/> Q3 (Jul-Sep) <input type="checkbox"/> Q4 (Oct-Dec)
<b>Project Title:</b> Evaluation of Gusset-less Truss Connection to Aid Bridge Inspection and Condition Assessment		
<b>Project Investigator:</b> Erin S. Bell <b>Co-Project Investigator:</b> Ricardo A. Medina <b>Phone:</b> (603)862-3850 <b>E-mail:</b> erin.bell@unh.edu		
<b>Research Start Date:</b> December 15, 2016	<b>Research End Date:</b> December 31, 2018	<b>Project schedule status:</b> <input type="checkbox"/> On schedule <input type="checkbox"/> Ahead of schedule <input checked="" type="checkbox"/> Behind schedule

The Memorial Bridge connecting Portsmouth, NH and Kittery, ME was re-opened to traffic in 2013. One of the major innovations of the reconstructed bridge is the first ever gusset-less truss connection in a vehicular bridge in the United States. Traditional gusset plates are the most vulnerable element in a truss-bridge structure and a source of significant cost, effort, and concern for bridge manager

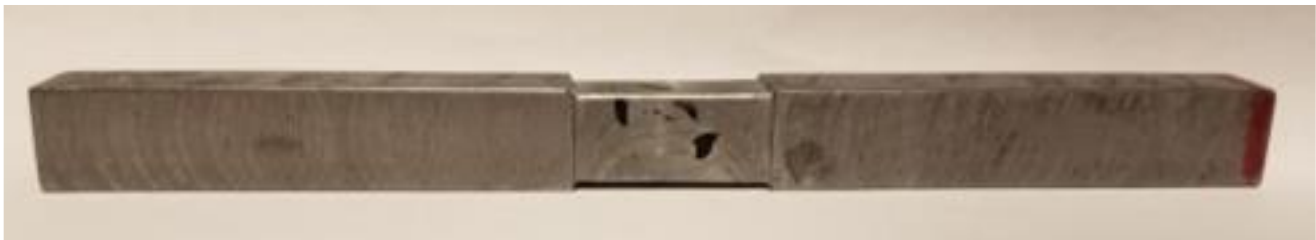
**Figure 1: Example Weld Specimen**

During the second quarter of 2017, weld specimens with and without defects were fabricated to evaluate the fatigue performance of intact and defective 7/16" welds (see Figure 1). As part of this effort, a mock test was performed. Due to limitations of the testing machine, significant slippage was present during the cyclic test and an alternative testing approach was designed. The Civil and Environmental Engineering Department procured grips to be attached to the Instron Universal Testing Machine at the UNH Structural Engineering Laboratory. The advantage of using the aforementioned grips is twofold: (i) the grips prevents any slippage in the response once the specimens are exposed to cyclic loading, and (ii) time and resources are saved given that specimens do not need to be machined to a circular cross-section and specimens with square cross-sections can be tested without modifications. Figure 1 shows one of the specimens to be tested. The only machining necessary involved reducing the cross-section in the middle of the specimen (where the weld is located) in order to induce fatigue failure at this location. The grips arrived toward the end of the third quarter and testing in October and November demonstrated that they were defective. Material Testing Technology (MTT) were contacted, and after a few weeks going back and forth with them, the original grips were returned, and a new set of grips were sent to us at the beginning of December. Further delays related to the testing apparatus have delayed the coupon testing to summer 2018. Fortunately, this testing can be done in parallel with testing of the small-scale specimens of the gusset-less connection.

Due to the focus on the fatigue testing in the small-scale connection during this quarter, the testing on the weld specimen was not performed in the third quarter of 2018 and it is planned to happen next quarter. The grips from Material Testing Technology (MTT) are still available for the test.

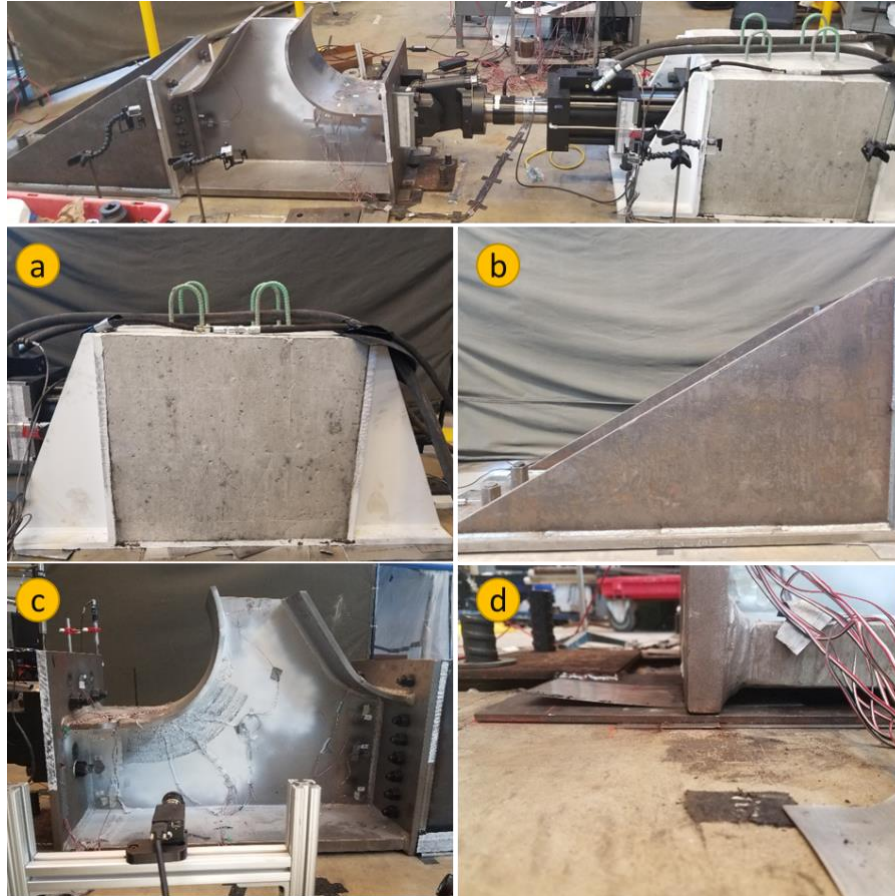
**Figure 2: System Components - (Left to Right) Overall Test Setup, Reaction Block (a), Bracket Support (b), Specimen (c), and Shim Support (d)**

The original test setup was evaluated by applying several monotonic load tests to characterize the behavior of the entire system. Based on these initial tests, modifications were made to the setup to create a more stable system in which the relative ratio of the rigidity of the supports, including their attachments to the strong floor, to the rigidity of the specimen increased. The most relevant changes included the following; pouring concrete inside the reaction frame to add stiffness, lowering the actuator to reduce stress concentrations on the vertical attachment plate on the actuator side, adding a support

under the tip of the specimen to prevent lateral loading on the actuator, and adding shims under the bracket and reaction frame to compensate for uneven sections of the floor under the test configuration. The entire setup, in its current (modified) state, is shown in Figure 2.

In addition to the physical test setup, a loading protocol was also developed for this test. The fatigue loading that is being used in this test is a pulsating tensile loading, in which, the actuator is cycling in force control as a sinusoidal signal in tension. The loading specifications are as follows:

- Mean axial load applied: 55 Kip (244.7 kN)
- Cyclic amplitude:  $\pm 50$  Kip (222.4 kN)
- Cyclic frequency: 3.5 Hz
- Applied function: Sine wave
- Cycles per Test Session: Fatigue = 25600 cycles, SI = 200 cycles
